HULL AND CARGO SURVEYORS, INC.
INLAND MARINE - INSPECTIONS - LOSS PREVENTION - SHIP & AIR CARGO
249 TEWKSBURY AVENUE, RICHMOND, CALIFORNIA 94801
TEL. (415) 524-4402

FILE # SFH 83052

February 2, 1984

Mr. Steve Hastings, Marine Maintenance Foreman, Hyde Street Pier Museum of Historic Ships, San Francisco, California. The undersigned marine surveyor did conduct an inspection/survey of the S/V "C.A. THAYER" at PACIFIC DRYDOCK AND SHIP REPAIR, Oakland, California on October 14, 1983 and subsequent dates for the purpose of ascertaining the condition of the vessel as outlined in U.S. DEPARTMENT OF INTERIOR contract order number PX8140-3-0760.

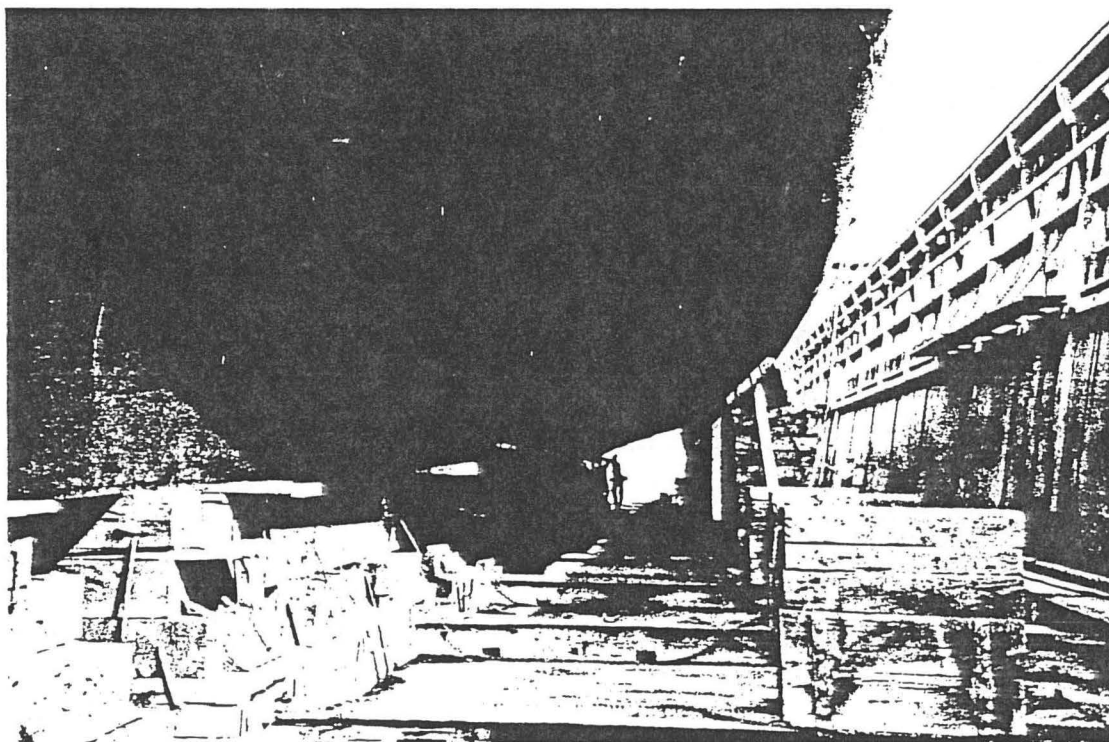
The "C.A. THAYER" was moved into drydock. Upon dewatering vessel, hog was measured at 14½" an increase of 1" since last drydocking in 1980.

PHOTO #1, "C.A. THAYER"
Noticable Hog.

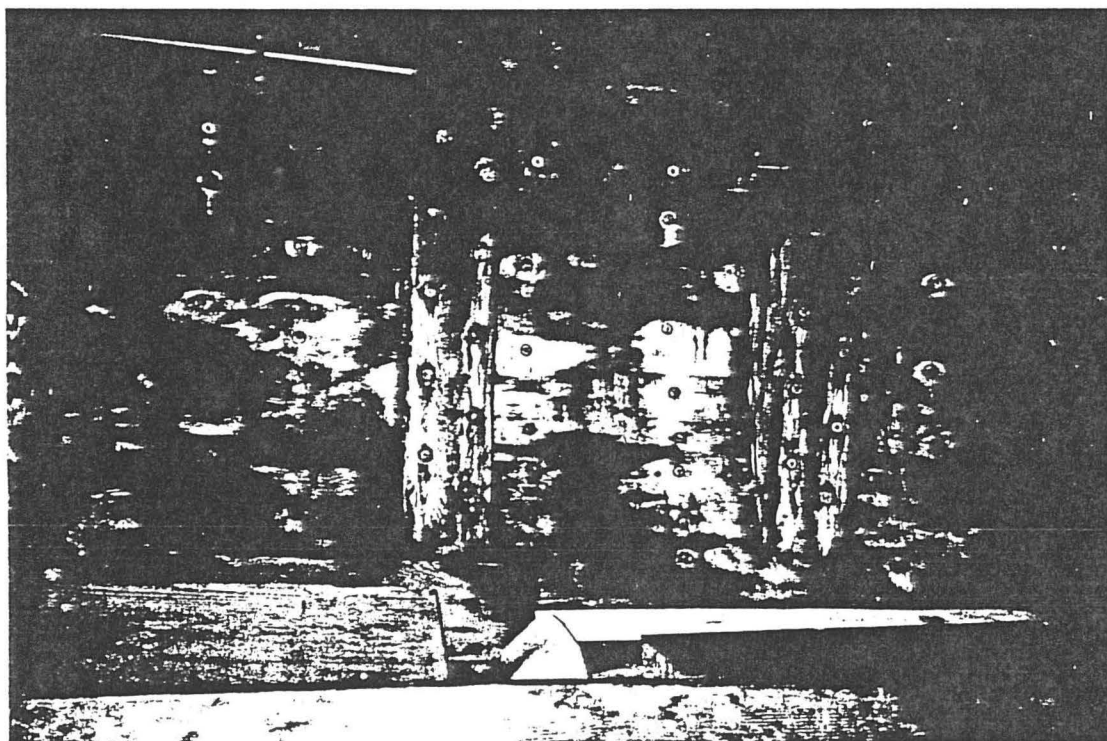
A cursory inspection was made of the working deck. Deck evidenced heavy pockets of decay and numerous exposed cavities which may be considered a tripping hazard to the general public. Obvious indications of water incursion below decks indicates serious deterioration of the deck throughout the vessel.

PHOTO #2, "C.A. THAYER"
Water stained interiors from deck leaks.

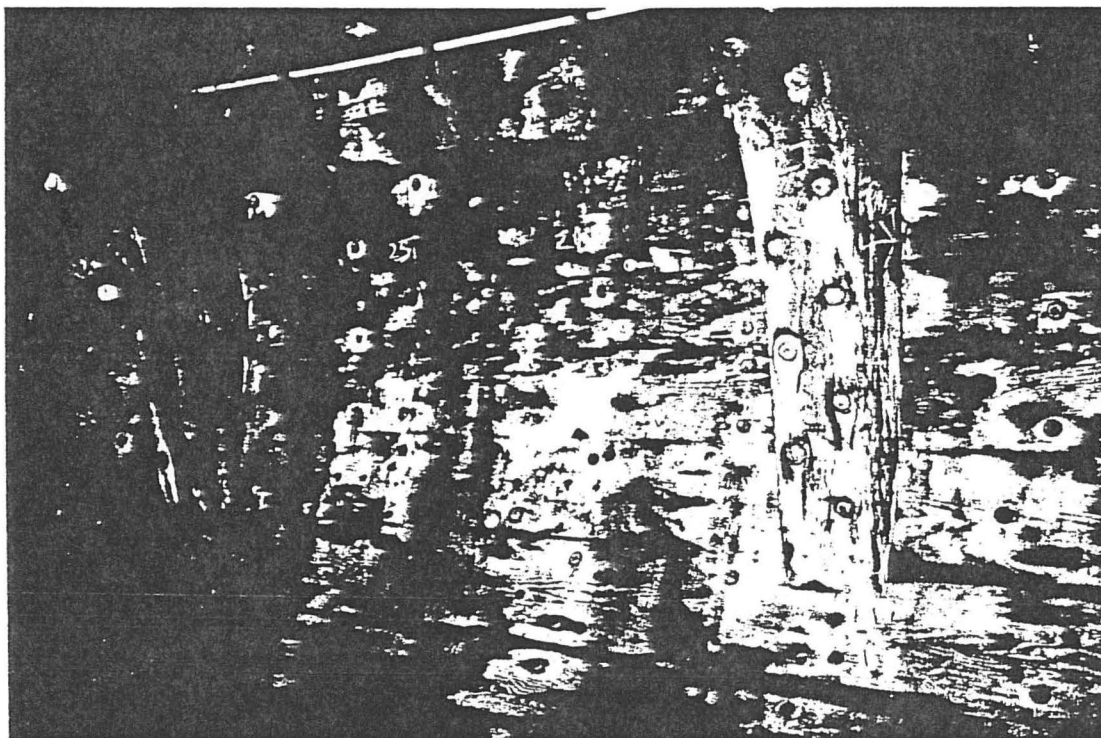
PHOTO #3, "C.A. THAYER"
Water stained interiors from deck leaks.

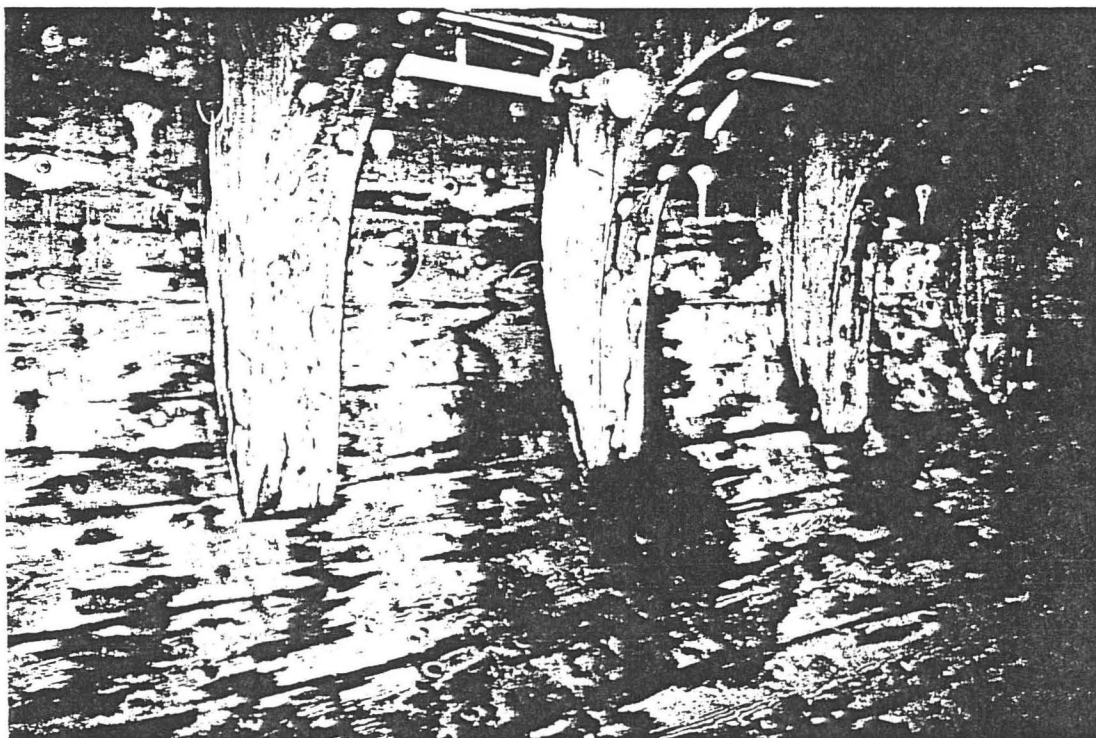
PHOTO #4, "C.A. THAYER"
Water stained interiors from deck leaks.

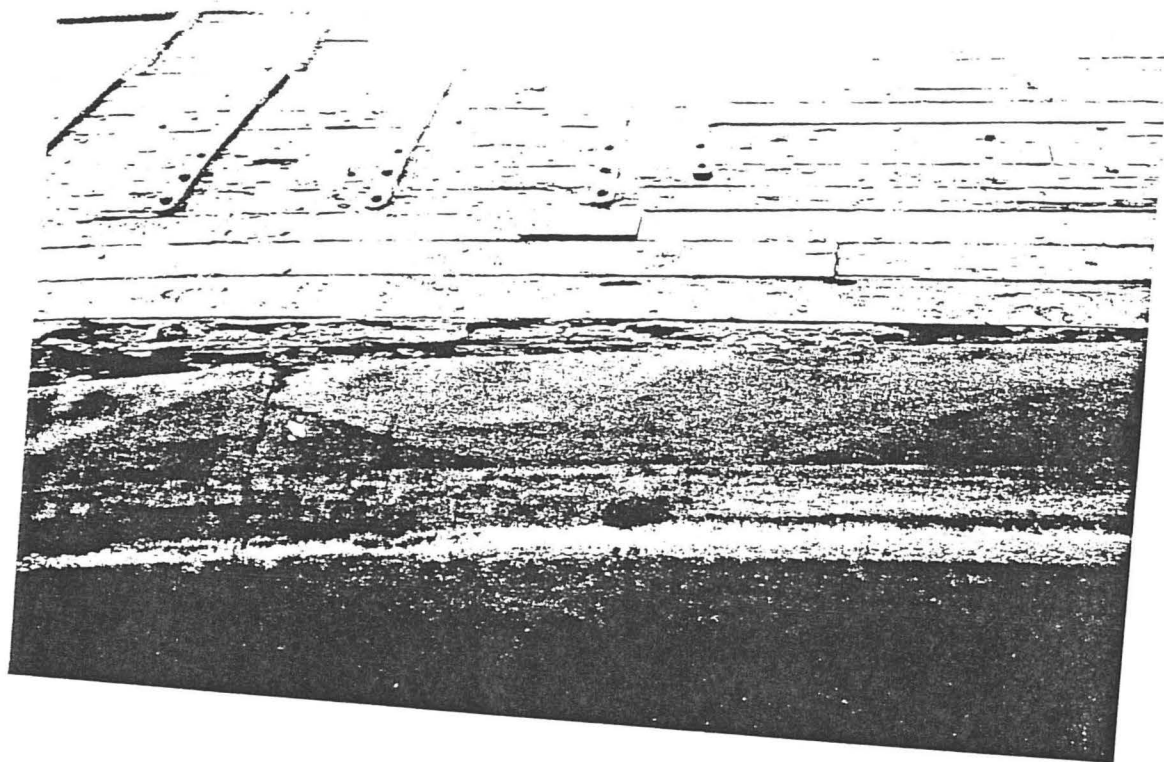
PHOTO #5, "C.A. THAYER"
Port side deterioration along wind and water strake.

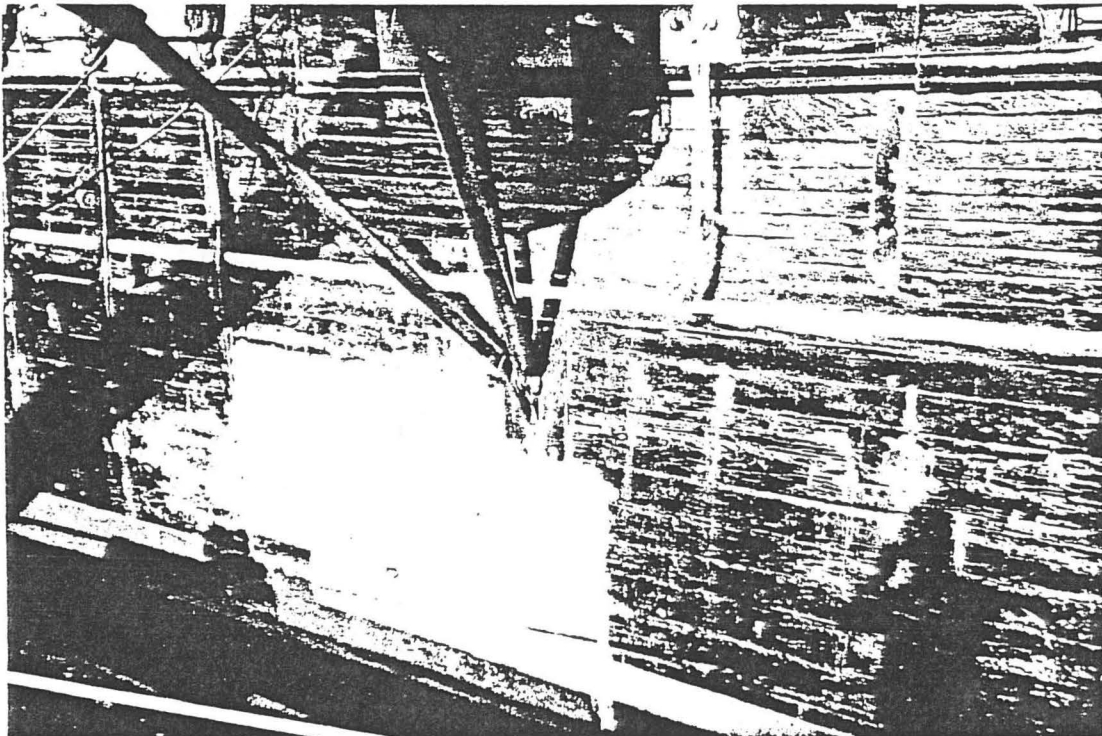
While the vessel was afloat work commenced on damaged hull planks located on the starboard beam. Damage stated to have occurred during a period of heavy weather, vessel holed herself along side the dock.

PHOTO #6, "C.A. THAYER"
Starboard beam damage.

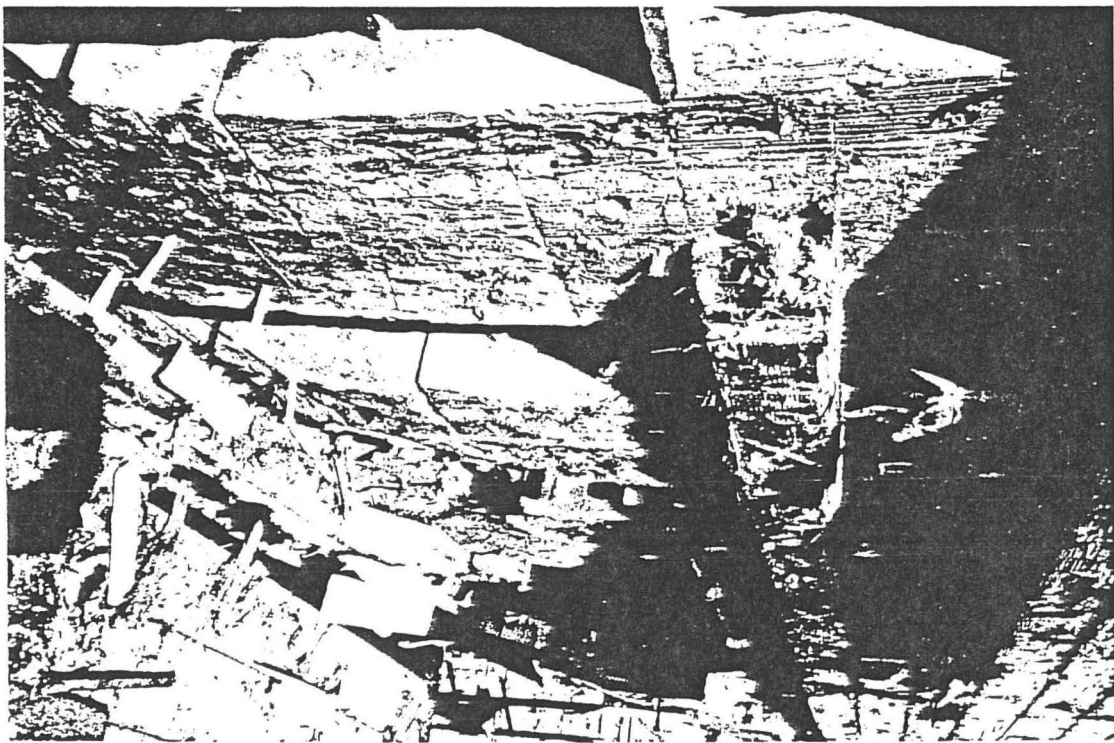
PHOTO #7, "C.A. THAYER"
Starboard beam damage in way of damage areas.

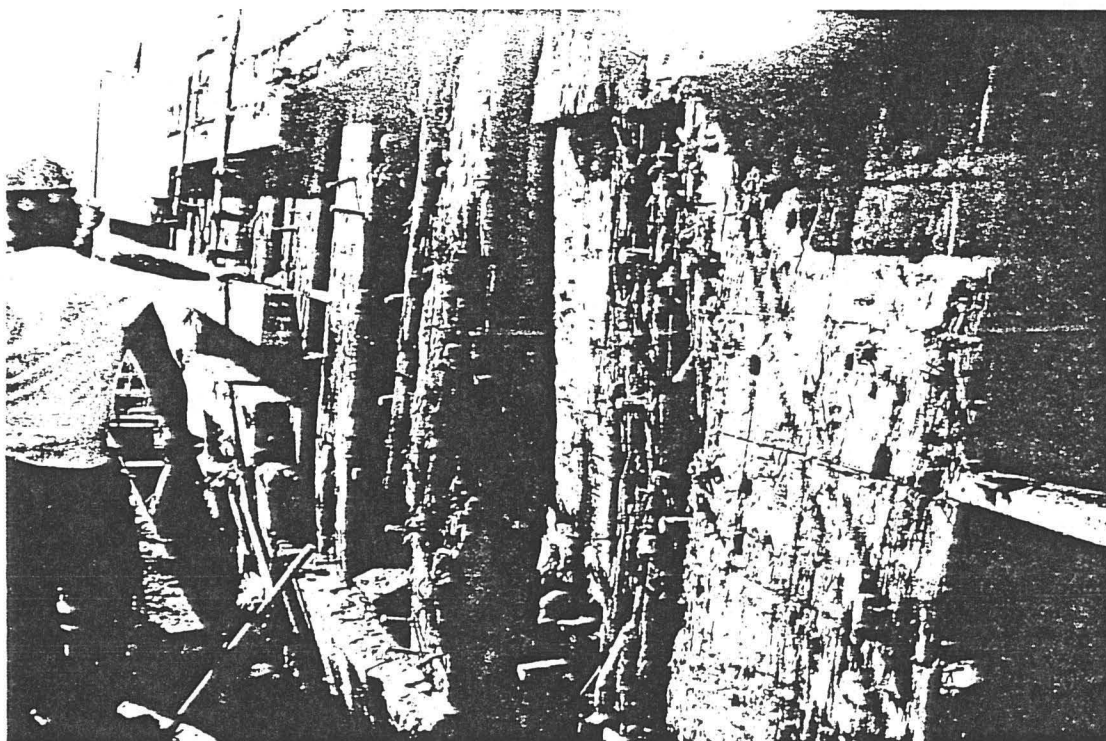
PHOTO #8, "C.A. THAYER"
Starboard beam damage in way of damaged areas.

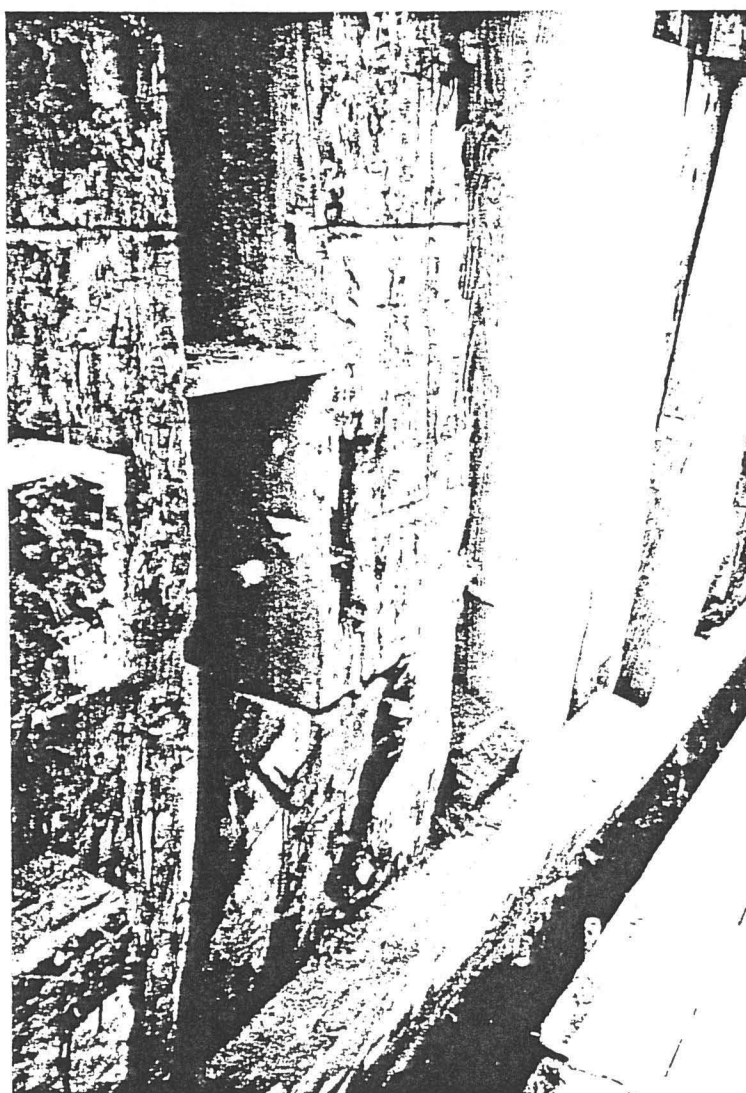
Vessel is felt to be in poor condition. Previous method of arresting deterioration have actually accelerated it. Plank removals at this dry docking revealed extreme deterioration to large numbers of structural members which were not repaired at this dry docking. Hull planking was renewed on starboard side only yet we have noted many areas port side of sprung planking and deterioration due in part to the lack of rotation of the vessel on an annual basis. It is our opinion that 75% of hull planking is in need of replacement on the port side, 50% on the starboard side. Repairs at this dry docking barely scratched the surface of deterioration found throughout the vessel. New timbers were added next to deteriorated timbers. Even with quantities of anti fungicide, rapid deterioration is expected.

PHOTO #13, "C.A. THAYER"
New work next to deteriorated wood.

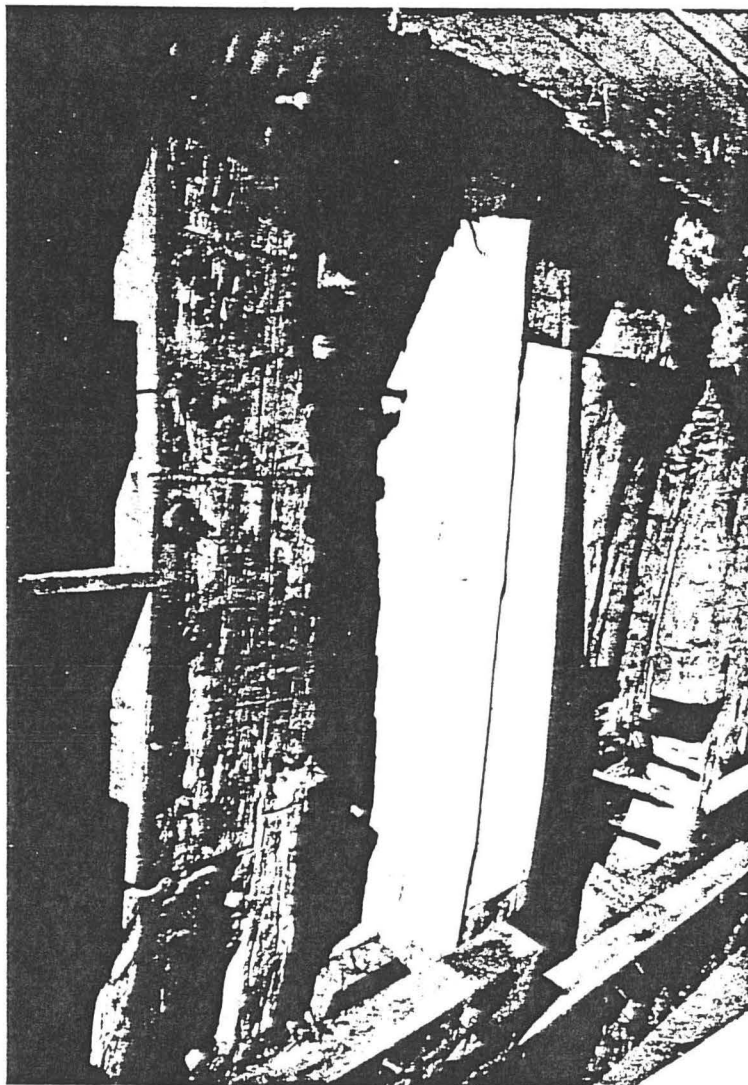
PHOTO #14, "C.A. THAYER"
New work next to deteriorated wood.

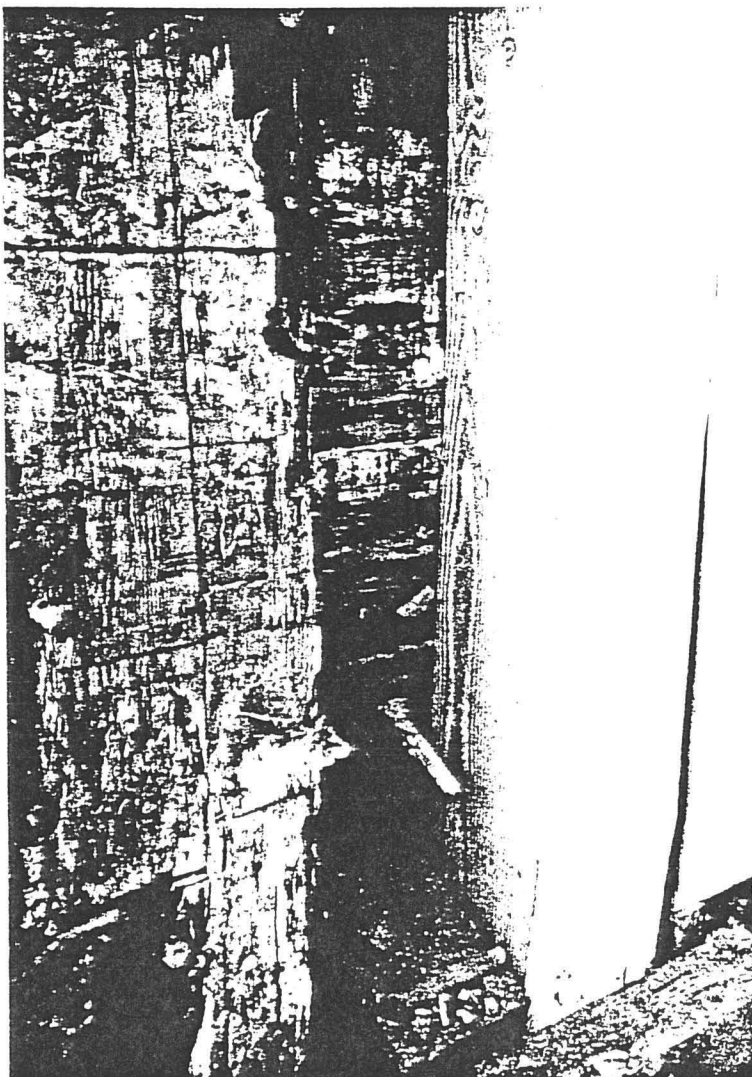
PHOTO #15, "C.A. THAYER"
New work next to deteriorated wood.

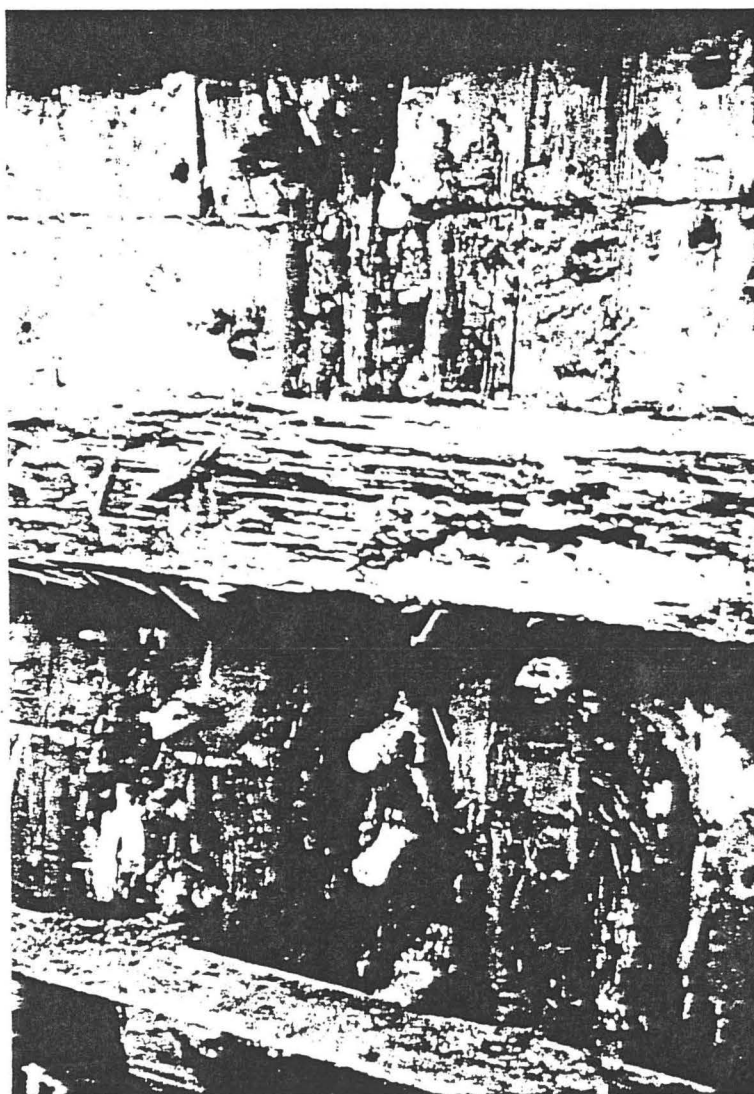
PHOTO #17, "C.A. THAYER"
Frame 25.

Forward Timber between side planks 3, 4 & 5 moderate to heavy.

Between side plates 6 and 7 heavy.

New Top Timber replacement at this dry dock between side plank 8, 9 and 10.

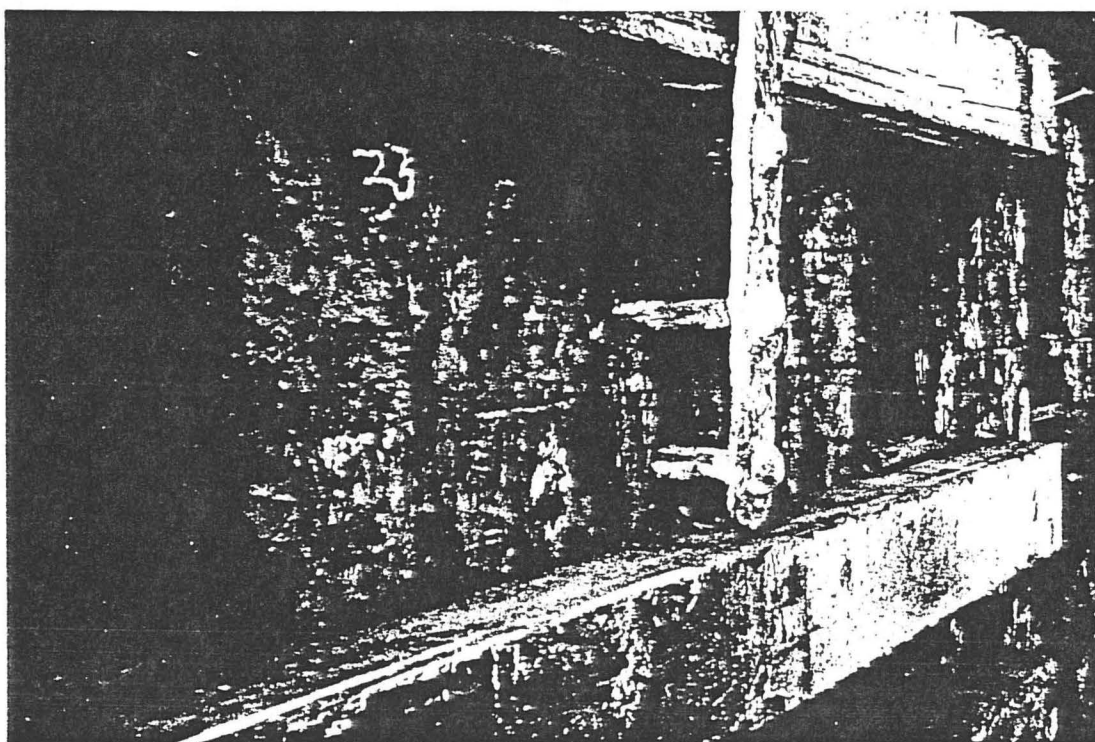
PHOTO #18, "C.A. THAYER"
Frame 33.

4-Top Timber 33, exposed at side planks 3, 4 & 5 moderate deterioration.

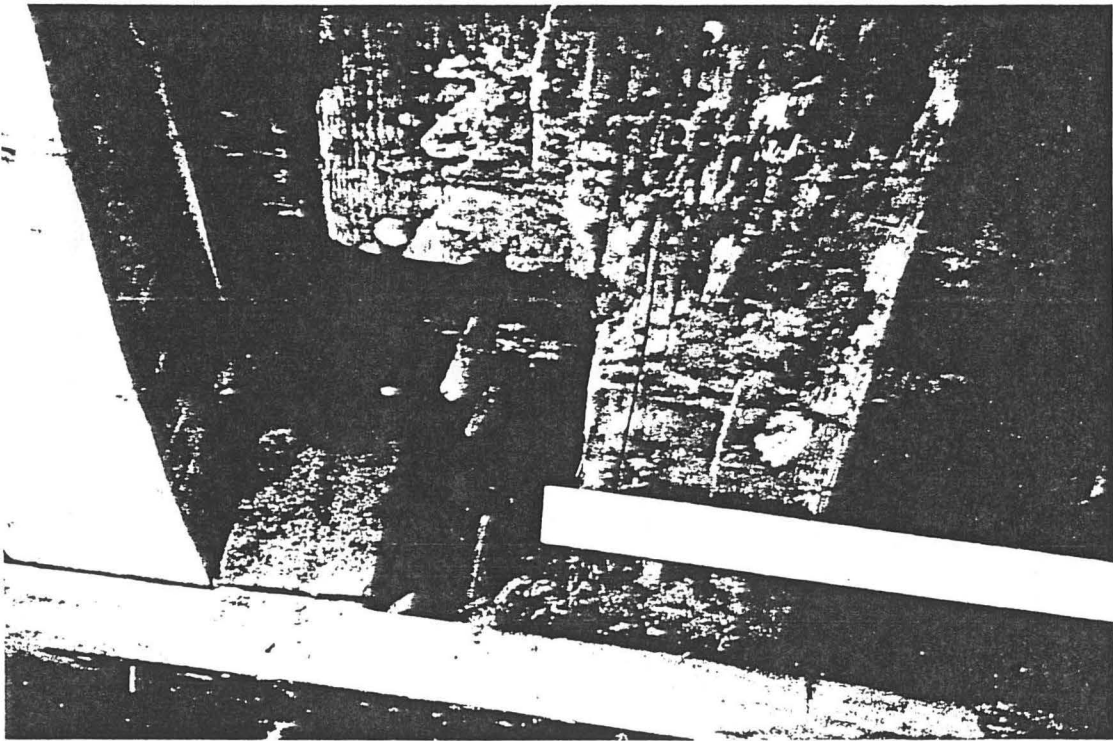
1-Forward Timber moderate between side planks 3-10.

2-Top Timber moderate between side planks 3-8, replaced as new this drydocking between side planks 9 and 10.

3-No frame, empty cavity.

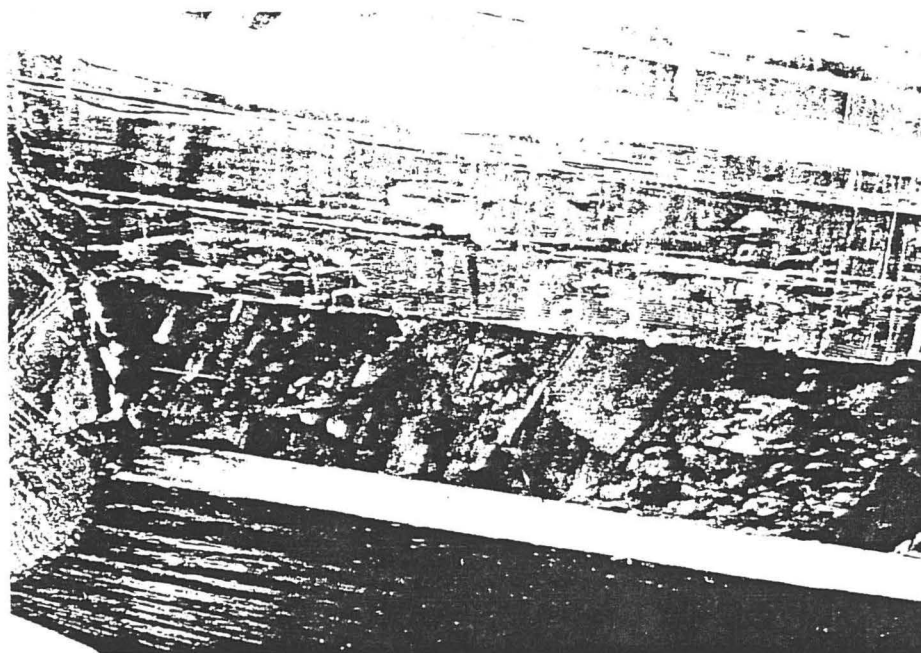
PHOTO #21, "C.A. THAYER"
Frame 63 to Transom.

Forward timber extremely deteriorated.

Aft timber extremely deteriorated, sistered to transom.
